6 National Dam Inspection Program, Old Dam (NDI ID Number PA-499), Ohio River Basin, St. Patrick's Run, Washington County, Pennsylvania, Phase I Inspection Report.

PHASE I REPORT  
NATIONAL DAM INSPECTION PROGRAM

NAME OF DAM: Old Dam  
STATE LOCATED: Pennsylvania  
COUNTY LOCATED: Washington  
STREAM: St. Patrick's Run, a tributary of Raccoon Creek  
DATE OF INSPECTION: November 29 and December 20, 1978

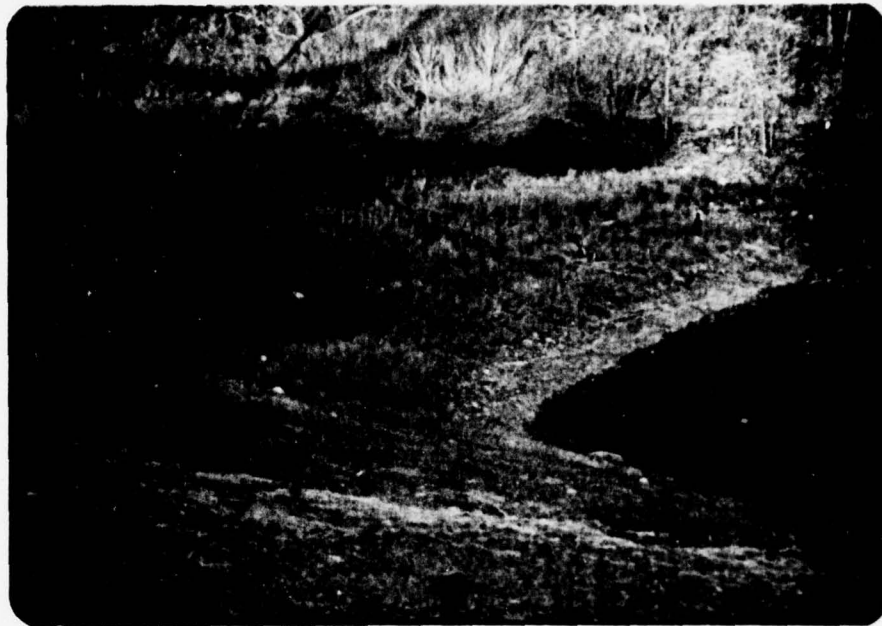
Upstream Face

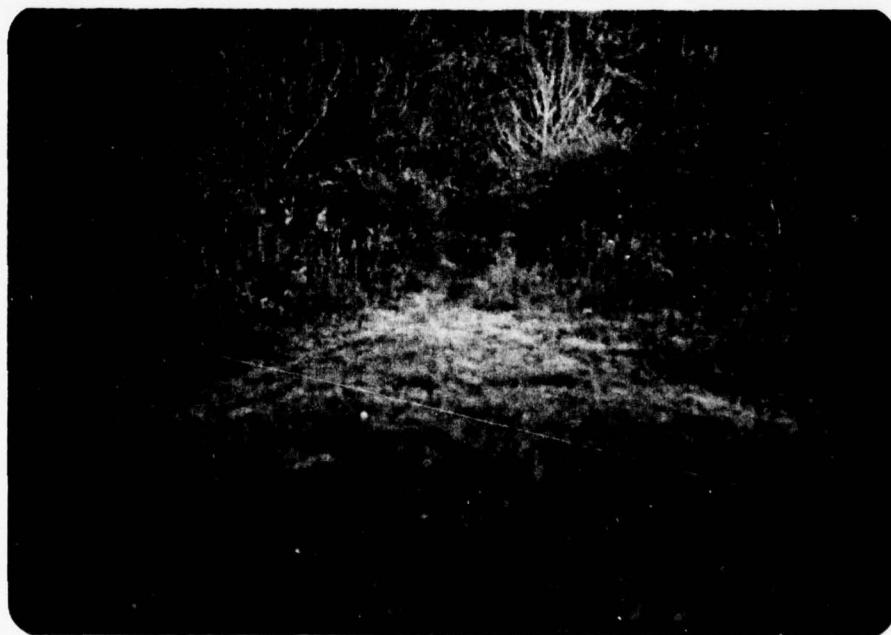
Photograph No. 2

The top of the dam was surveyed relative to the spillway crest elevation and was found to have several vertical irregularities. While the design freeboard of the dam was four feet, the survey indicated freeboards ranging from 3.9 feet to 6.3 feet. The lowest point occurred approximately 100 feet from the spillway wall.

Crest (looking west, view from left abutment).

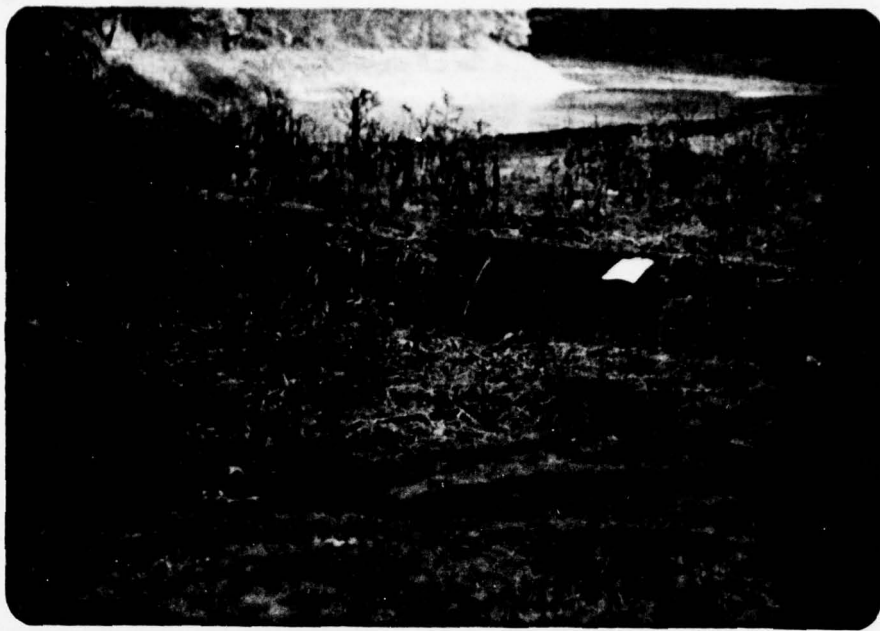
Photograph No. 3

VISUAL EXAMINATION OF	OBSERVATIONS	REMARKS OR RECOMMENDATIONS
CONCRETE WEIR	49-foot-wide stone overflow weir. In poor condition.	
APPROACH CHANNEL	Free of debris and major obstructions.	
DISCHARGE CHANNEL	Some overgrowth in this section immediately downstream from the overflow structure. The remaining portion of the discharge channel is free of obstructions and is in fair condition.	Requires clearing.
BRIDGE AND PIERS	None.

Spillway channel and approach channel.

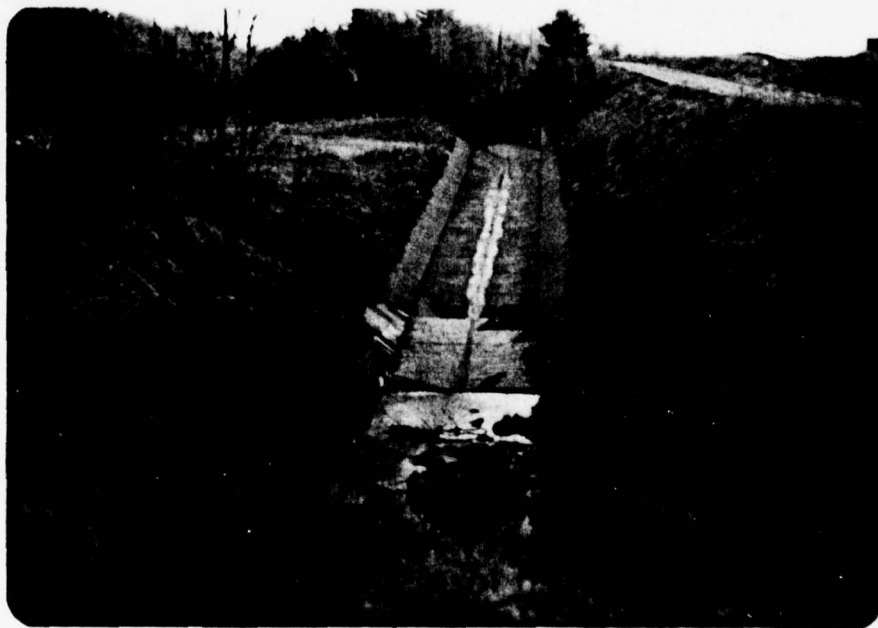
Photograph No. 4

Spillway discharge channel.

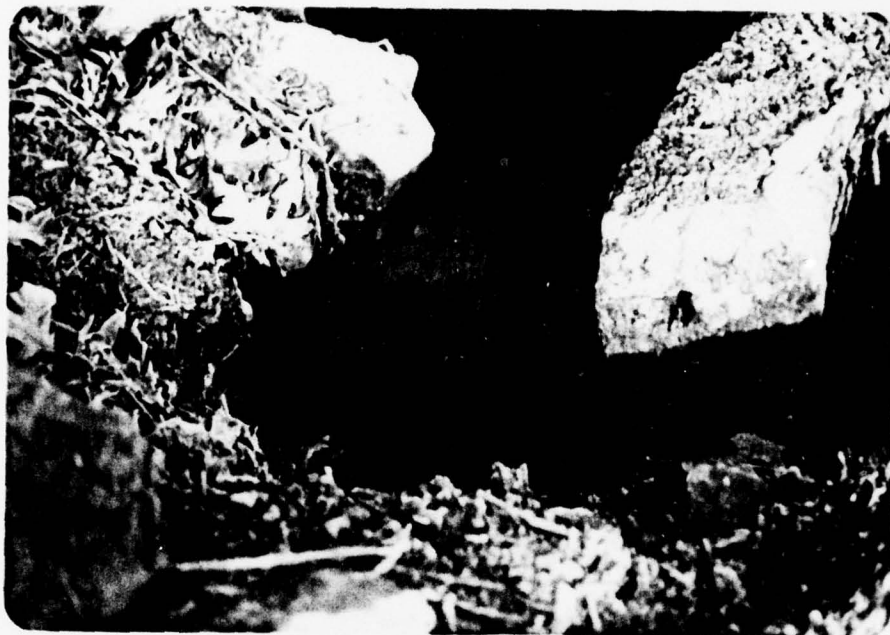
Photograph No. 5

(2) Appurtenant Structures. No portions of the outlet works for the dam were visible. Apparently, the intake tower for the outlet works has collapsed. Presently, water enters into the outlet pipe through a mound of rubble at the upstream toe of the dam. Reportedly, the valve on the outlet pipe located at the downstream toe of the dam has also been dynamited. Due to the poor condition of the visible portions of the outlet works, concern exists as to the structural integrity of portions of the outlet works through the embankment.

VISUAL EXAMINATION OF CRACKING AND SPALLING OF CONCRETE SURFACES IN OUTLET CONDUIT	OBSERVATIONS	REMARKS OR RECOMMENDATIONS
	No portions of the outlet conduit are visible.	
INTAKE STRUCTURE	The intake structures have apparently collapsed. Water enters through the outlet conduit to a mound of rubble.	Rubble should be cleared and necessary repair should be performed.
OUTLET STRUCTURE	Submerged. Not visible.	
OUTLET CHANNEL	No defined outlet channel. There is a pool approximately 50 feet wide and 200 feet long downstream from the dam. This pool overflows into the spillway discharge channel at an elevation higher than the ground surface at the toe of the dam. A drainpipe in the spillway discharge channel is apparently connected to this pool.	The pipe in the discharge channel is apparently not functioning since the pond is not drained.
EMERGENCY GATE	Not visible (as reported by the owner, the valve on the outlet pipe has been dynamited in an attempt to drain the lake).	Condition of the discharge and outlet pipe should be evaluated.

Intake end of outlet conduit. (Water percolating into a mound of rocks. Downstream end could not be located.)

1. Have the dam and appurtenances evaluated by a professional engineer either for orderly abandonment and breaching of the dam or for repairs and restoration of the outlet works and embankment and enlargement of the spillway to provide adequate spillway capacity. If the owner decides to breach or remove the dam, additional hydrologic and hydraulic studies should be performed to evaluate the downstream effects of this action.
